REPORT OF THE R. 101 INQUIRY

*Presented by the Secretary of State for Air
to Parliament by Command of His Majesty,
March, 1931*

WHEREAS an accident arising out of or in the course of air navigation occurred on the 5th October, 1930, near Beauvais, France to the airship R.101.

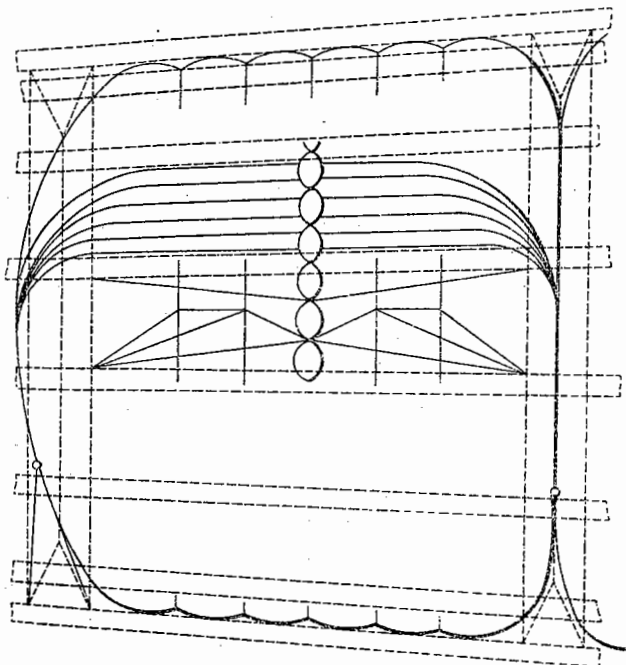
FIG. 5 (b).

remains flat, but, in the event of the bag on one side becoming deflated, pressure on the wire bulkhead becomes unequal and it curves in the manner shown on the left-hand side of Fig. 5 (b).

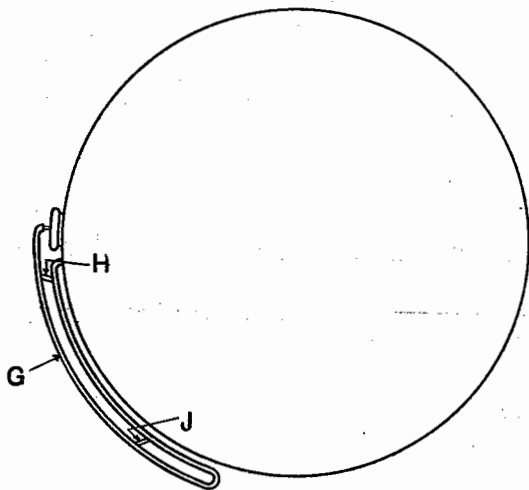
FIG. 6 (b).

It will be seen in Fig. 6 (b) that two cross-connections exist in the siphon pipe marked H and J.

If connection H is opened, gas will enter the operating chamber and open the valve, even if the bag is considerably deflated, and this method of opening the relief valves avoids the necessity of providing separate manoeuvring valves.

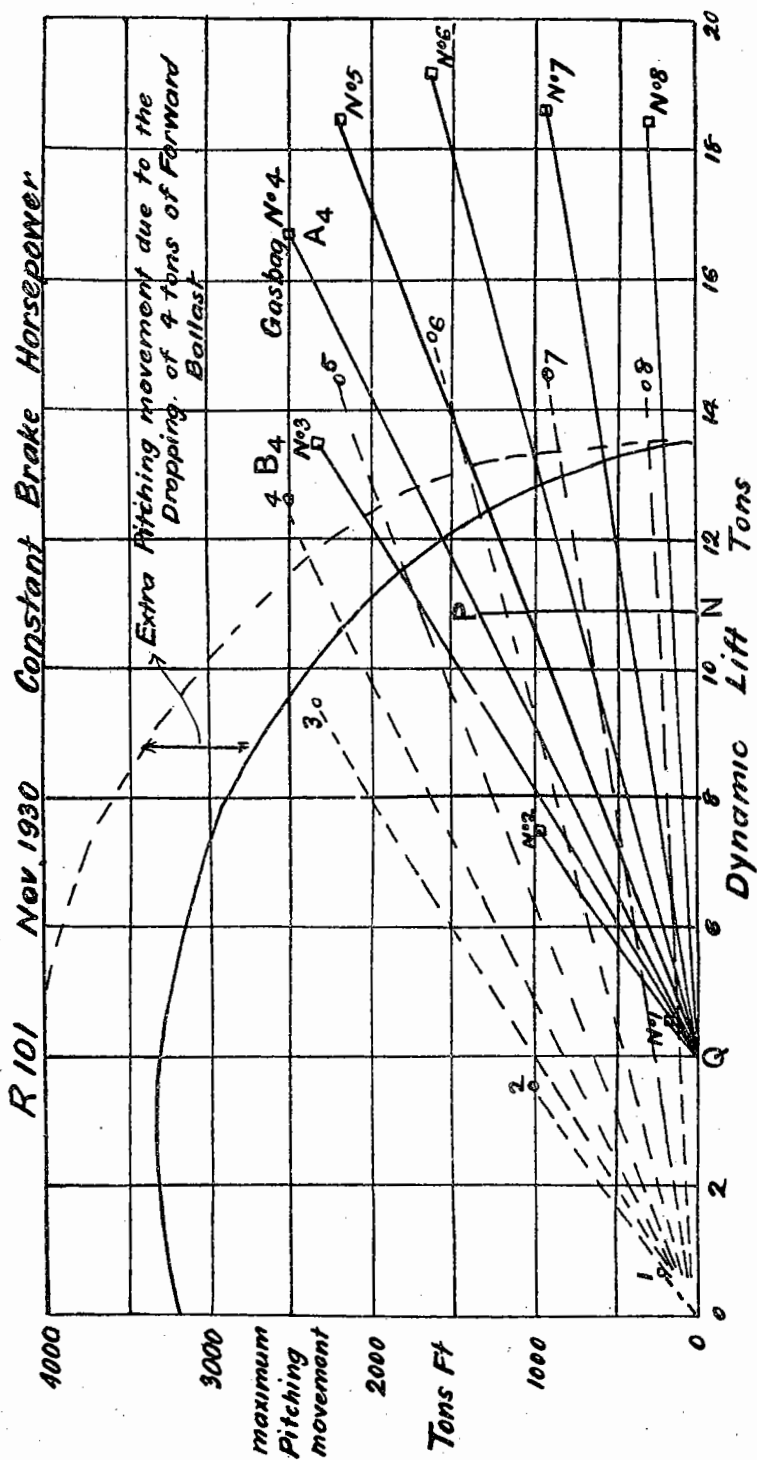
FIG. 2.

the total aerodynamic lift called for is 16.65 tons and the downward pitching moment to be corrected is 2,511 tons feet. These two quantities define a point A_4 on the diagram, which is well outside the region of possible aerodynamic control, as shown by the full line on the diagram, the limit being reached when the bag is about 60 per cent. deflated. Similar points corresponding to the total deflations of gas-bags Nos. 1, 2, 3, 5, 6, 7, 8 are located on the diagram and it is evident that aerodynamic control alone is insufficient to cope with the complete deflation of any one of the gas-bags Nos. 4, 5, 6, 7, 8.

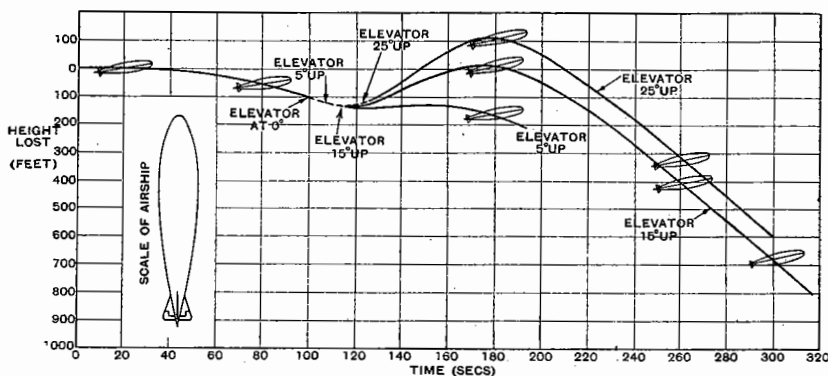
FIG. 3.

- Curve A Elevator put up from 0° to 5° at 1° per sec.
- " B " " " 0° " 15° " "
- " C " " " 0° " 25° " "

This point is brought out clearly by cases 1, 2 and 3 (see Fig. 3). Initially, that is when $t = 0$, the ship is supposed to have become 12 tons heavy, of which 8 tons is due to deflation in gas-bag No. 5, the remainder being general heaviness. It is furthermore assumed that gas-bag No. 5 continues to lose lift at the rate of 1 ton per minute. Initially the ship is flying pitched up 9.8° , with the elevators $1\frac{1}{2}^\circ$ down. Under the initial conditions assumed and with the engines running at their normal cruising H.P., the ship has just reached that state of general and local heaviness which makes it impossible for her to maintain height, though at first the rate of descent will be slow.

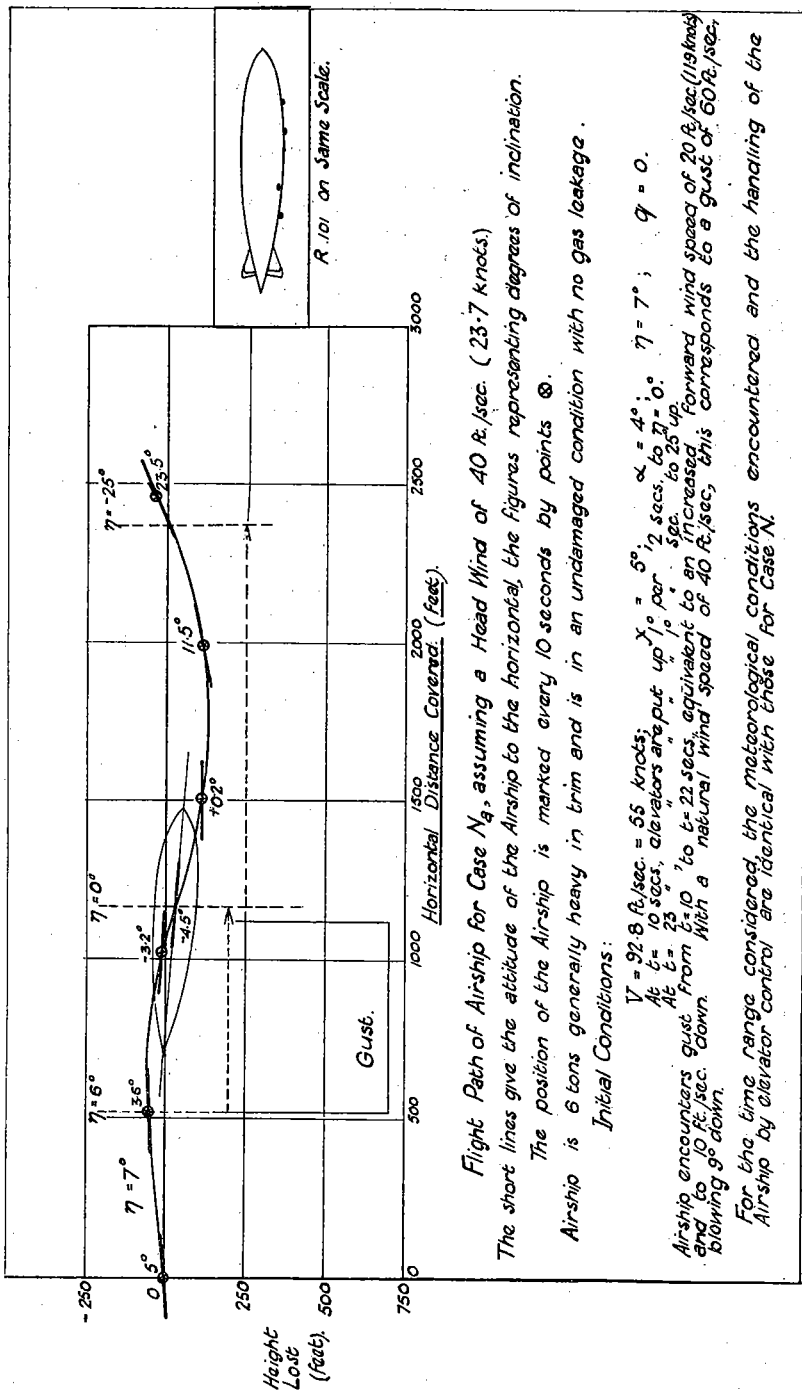
Flight Path of Airship for Case N_a , assuming a Head Wind of 40 ft./sec. (23.7 knots).

13. The curve of descent shown in Fig. 6 will err, if it does err, probably in the direction of understimating the effects of a deflated gas-bag and it is possible that a similar path might in reality result from less drastic assumptions relating to loss of gas and increased drag. Such modifications however are only quantitative in character, and do not affect the general conclusion that the causes which forced R.101 to the ground, were loss of gas in the forward part of the ship combined with a down gust and probably increased drag.
