REPORT OF THE R. 101 INQUIRY

*Presented by the Secretary of State for Air
to Parliament by Command of His Majesty,
March, 1931*

WHEREAS an accident arising out of or in the course of air navigation occurred on the 5th October, 1930, near Beauvais, France to the airship R.101.

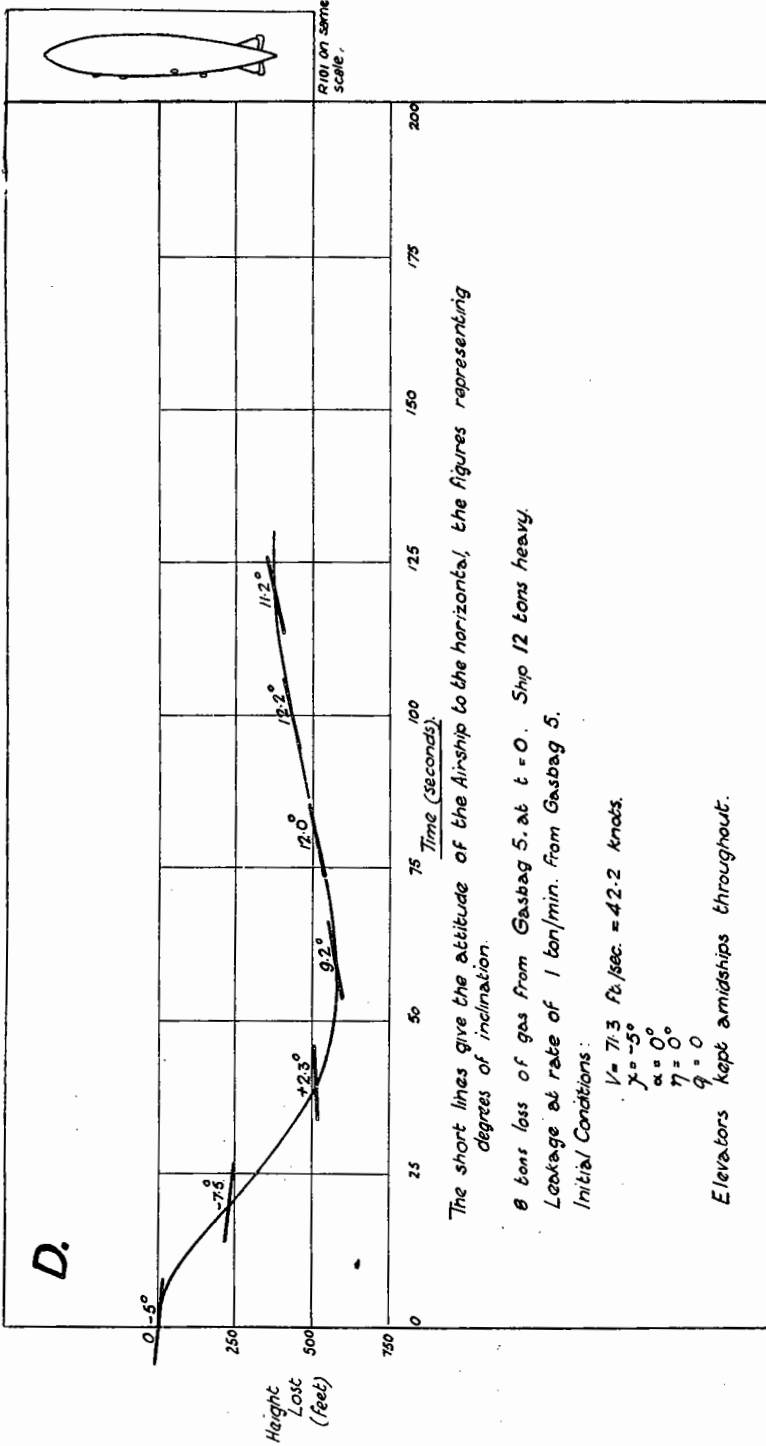
FIG. 4.

8. Case 4 (Fig. 4) was worked out to investigate how the ship would behave if initially she was flying with her axis inclined downwards through an angle of 5° , this initial downward inclination having been produced by a buffet of wind or by a downward movement of the elevators. The conditions assumed for heaviness and progressive deflation are the same as in the previous case, but the elevators are supposed to remain in mid-position for the whole period of 125 secs. It will be seen that the ship dives down through a height of over 500 feet, but, in spite of no assistance from the elevators, she never assumes a steep downward inclination. She soon gets her nose up again, and after about 1 minute, apart from loss of height, she is practically flying under the same conditions, as she was at the commencement of Fig. 3. Fig. 4 indicates that even without elevator control, although the ship is very nose heavy, an initial dive does not become seriously intensified. Automatically she succeeds in getting her nose up again and, if the elevators had been put up at an early stage, the recovery from the dive would have been noticeably accelerated.

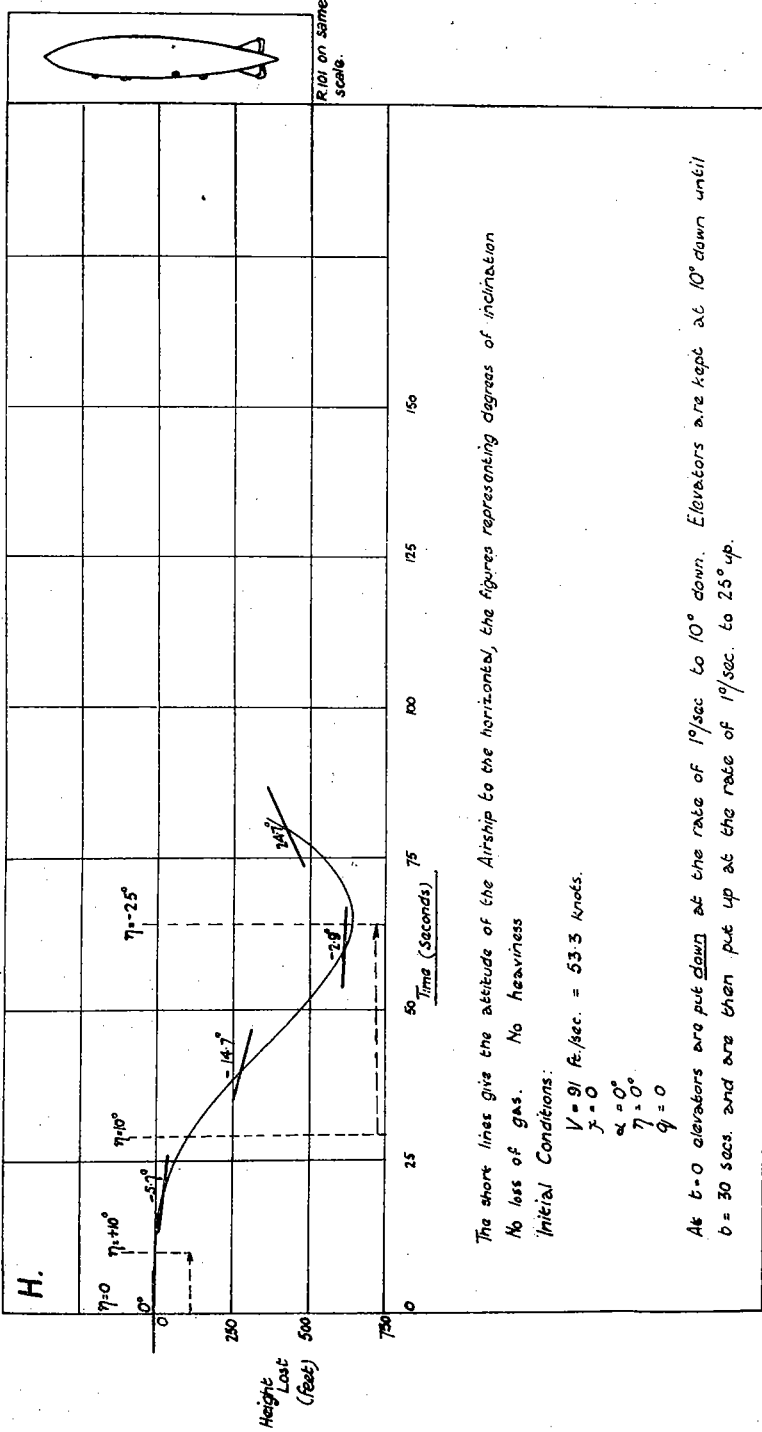
FIG. 5.

9. Case 5. Fig. 5 illustrates the recovery from a steep dive produced by the use of elevators. The ship is supposed to be flying without any heaviness, either general or local, at her normal cruising speed of 55 knots.

The initial dive might equally well have been produced by a strong downward buffet of wind striking the nose of the ship, and this case is illuminating, in that it shows how errors in the use of the elevators or down currents of air may produce dives of considerable magnitude, but, as long as the ship is not seriously crippled with heaviness, a proper use of the elevators will enable her to climb again with great vigour. The outstanding feature of the descent of R.101 was that after the first dive, although she momentarily attained a horizontal position, she had evidently lost her power to regain altitude. To use a nautical simile, she had become "water-logged." This circumstance, combined with the fact that her first dive was nose downwards, suggests a combination of adverse conditions, namely, an extensive forward gas-bag deflation combined with a buffet of wind which forced her nose down and started her in a steep dive. The possibility of eddies from the Beauvais Ridge, which was not far distant to windward, makes this latter assumption not unreasonable. The ship was approaching a region where "bumpy" conditions might be anticipated, and the comparative absence of previous dives may be accounted for by the fact that until she reached the scene of the disaster, she had not been flying over country which would be likely to have a disturbing effect on the air currents.
